Transportation
Asset Management

Roads and Sidewalks in St. Albert

Date August 12, 2019

Transportation Infrastructure Engineer City of St. Albert

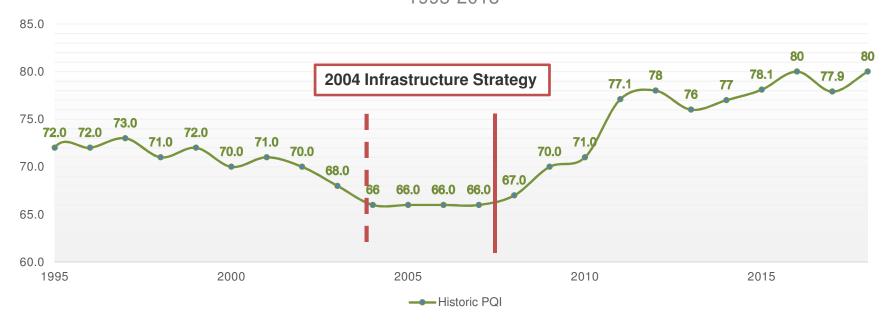
St. Albert Historic Network PQI 1995-2018

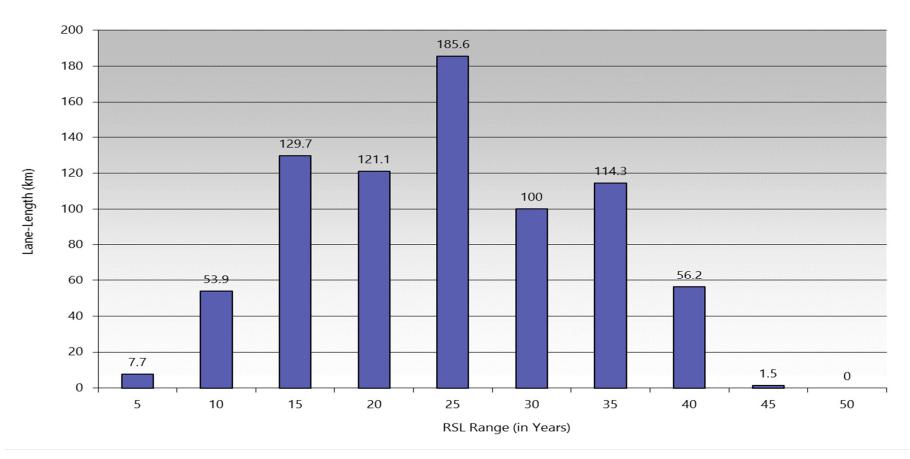
Network Remaining Service Life Distribution

RSL(22.5)

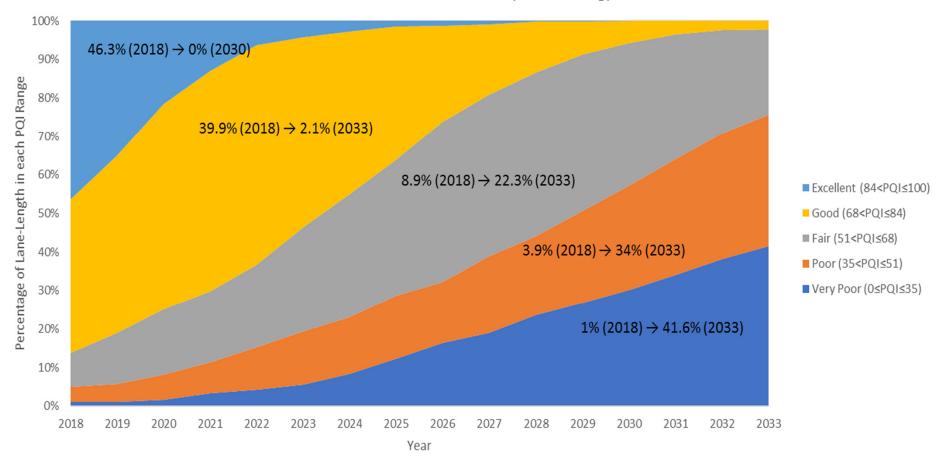
Network PQI Prediction (Do-Nothing)

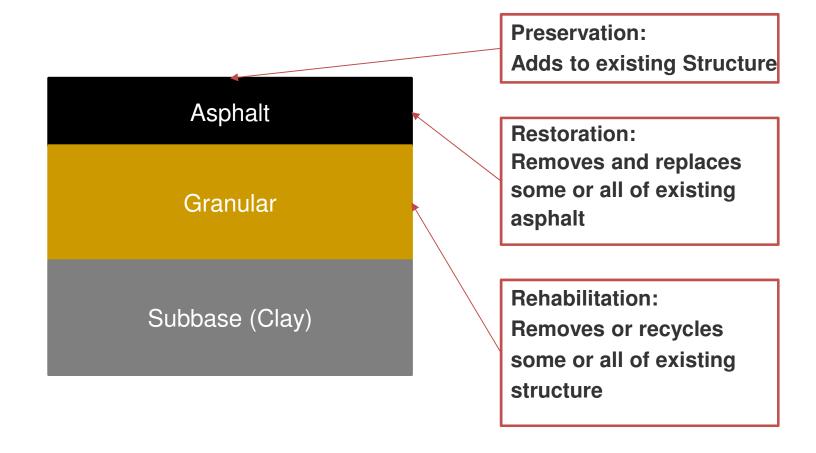
St. Albert Treatment Chart [2]

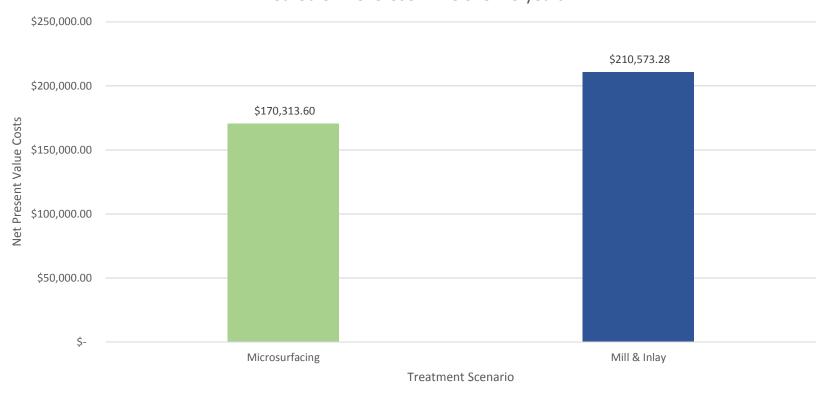
Life Cycle Comparison of Microsurfacing to Traditional Mill & Inlay Scenario using NPV method on Bellerose Drive over 25 years

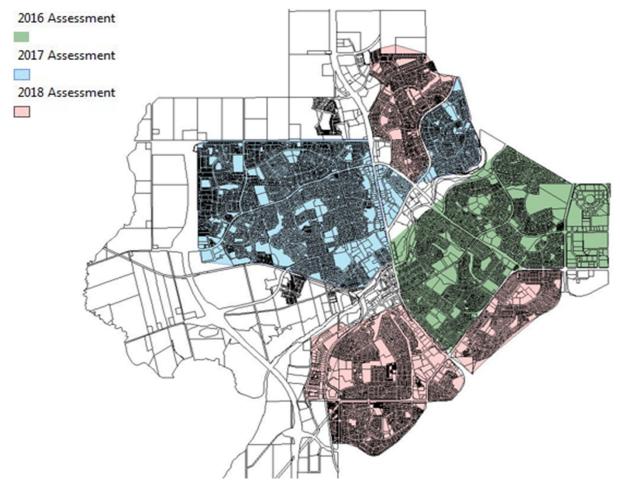
Overview of Sidewalk Condition Rating in St. Albert

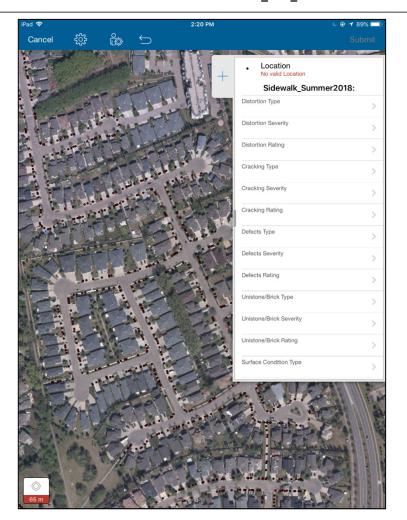
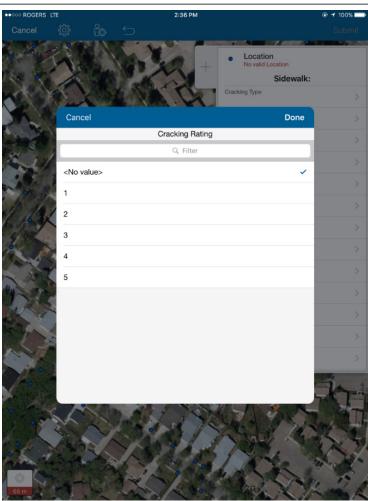
Screenshot of ArcGIS Collector App

- To accomplish these goals, the City invested in new technology for GIS
 - Split City into 1/3 segments
 - Used ESRI Collector App
 - Purchased an iPad Mini to do assessment

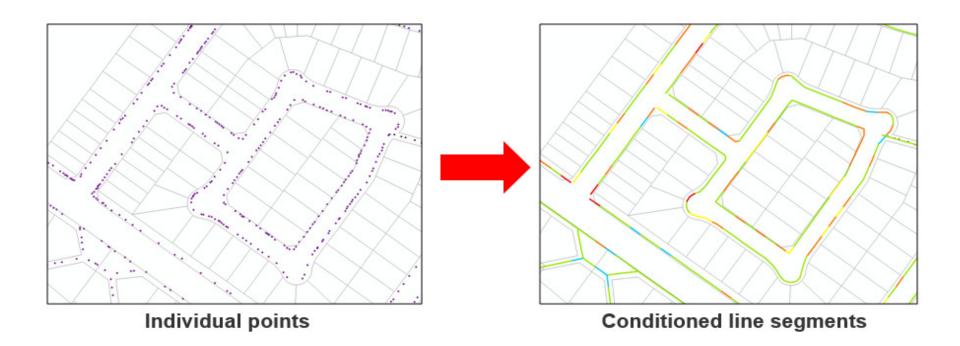
- 10 meter sidewalk segments (6 panels)
- Points grouped by nearest 10 meter segment
- ArcMap points transferred to Excel
- Algorithms condition rate (1-5) the segments

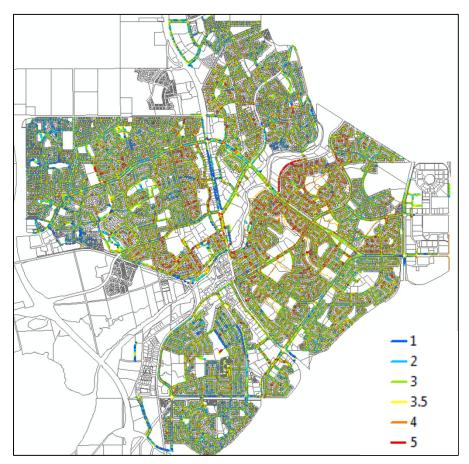
Condition rating of St. Albert with parcels

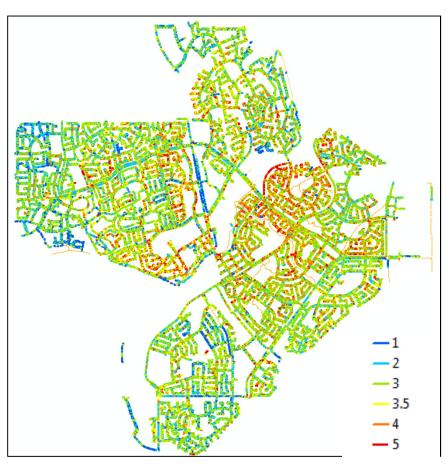
Condition rating of St. Albert excluding parcels

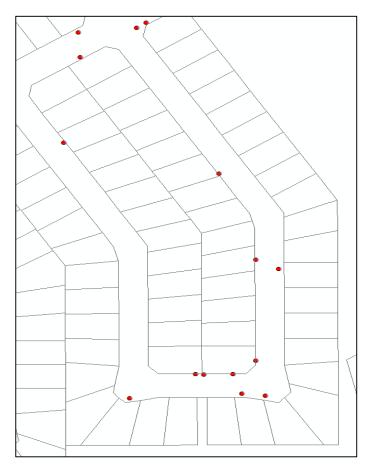
- Number of shaveable trip hazards:
 1013
- Number of trip hazards: 2035
- Percentage of shave-able trip hazards: 49.8%

Trip hazards in a neighborhood
